## 8. DEBRIS RELOCATION SCENARIO

J. R. Wolf and D. W. Akers, Idaho National Engineering Laboratory  
L. A. Neimark, Argonne National Laboratory

This section presents one possible scenario describing the relocation of debris to the lower head of the reactor vessel and is based on available plant instrumentation records and post-accident examination results. The scenario presented here is not the only potential debris relocation scenario, but is consistent with information obtained from plant data, VIP examinations, analysis efforts, and other TMI-2 programs.

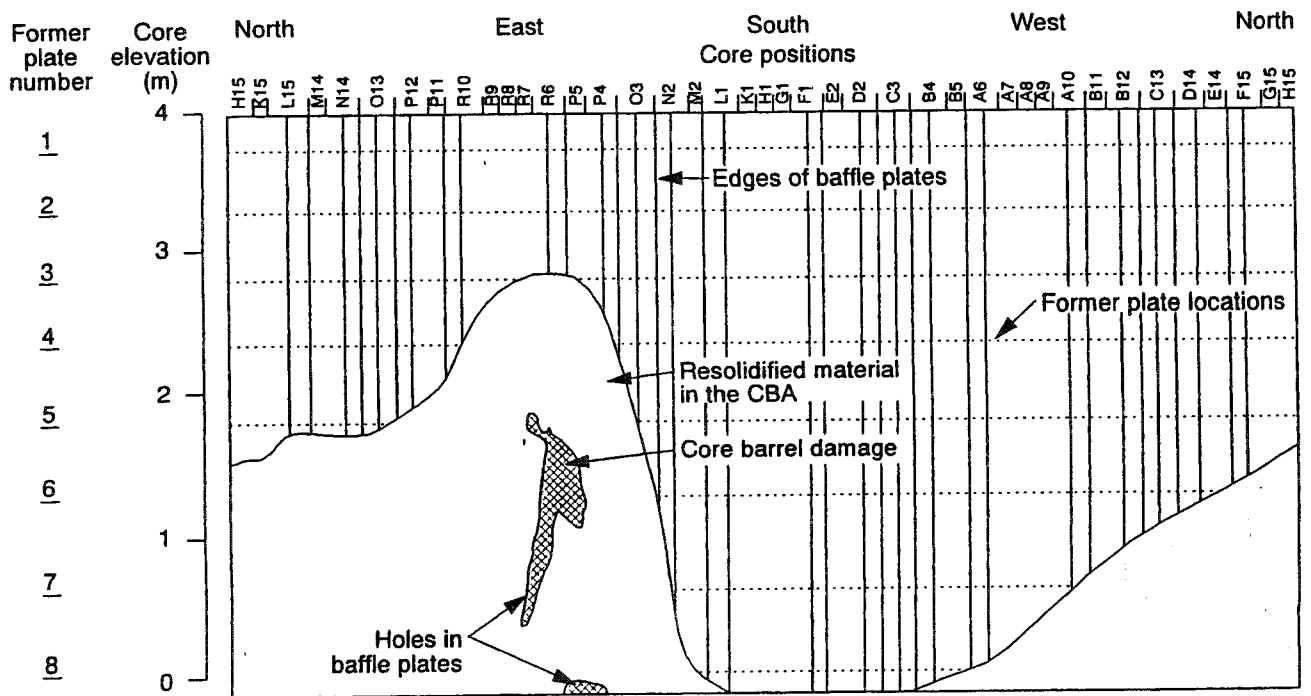
Figure 8-2. Fuel debris profile inside core former (laid flat).

Post-accident examinations of the eastern half of the core region and lower vessel internals confirmed plant instrumentation data and showed that relocation of the fuel debris to the lower head occurred in the eastern half of the vessel. Overall, approximately 19 metric tonnes of material reached the lower head. As discussed in Section 5, the relocated material was primarily a (U,Zr)O<sub>2</sub> ceramic. Visual examinations of this part of the vessel during defueling indicated that the primary path through the vessel was through a hole melted in the R6 vertical core former wall and then downward through the horizontal baffle plates. Figure 8-1 shows a cross section of the reactor vessel internal structure. Fuel melt was found in the P-5 and R-6 assemblies near the bottom of the fuel assemblies, which indicated that some liquified fuel had drained into these assemblies and solidified during the relocation. However, as no flow path was found through these assemblies to the lower head, the principal relocation path was identified as being through the damaged core former at the R-6/P-5 core locations. Three holes in the core former wall were identified. Dimensions of the holes through the former wall ranged from 23 × 3 cm to 20 × 7 cm.<sup>9,10</sup> The damage to the core former wall was about 140 cm from the bottom of the core or a little below the midpoint of the reactor core. The damage location is indicated in Figure 8-2.

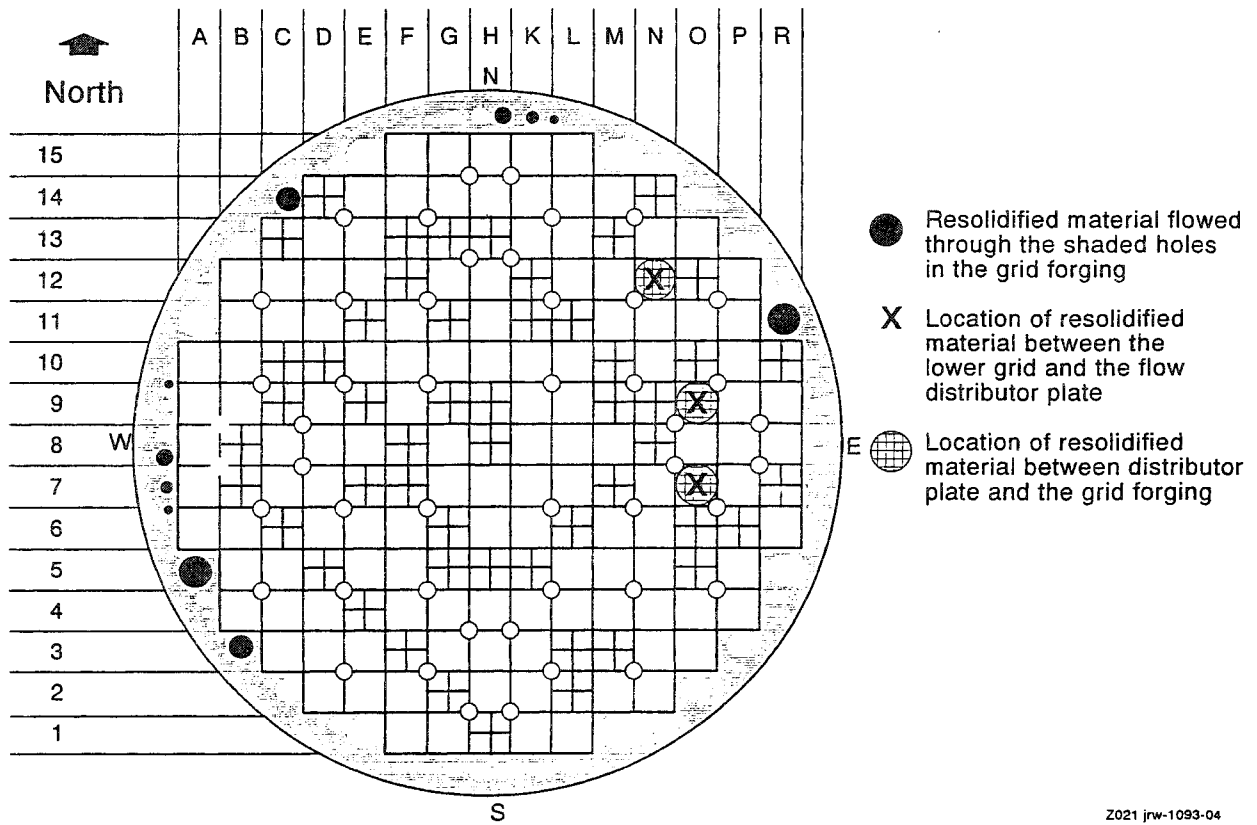
Figure 8-4. Solidified material in core support assembly.

The CSA geometry consists of a number of plates and forging and as shown in Figure 8-3. Once in the CSA, the majority of the molten material continued to flow down through the structures on the eastern periphery in the R-6/7 and P-4/5 area. However, visual examinations indicated that some of the molten material was found to have flowed around the perimeter of the CSA structures as it penetrated downward towards the lower head. Figure 8-4 shows the location of solidified material at several locations in the flow holes of the lower grid, the area between the lower grid and the flow distributor plate, and between the flow distributor plate and the grid forging. The presence of solidified material is assumed to indicate that molten material flowed through or adjacent to these locations.

Based on the locations of solidified material in the CSA as shown in Figure 8-4, it is postulated that the molten material flowed onto the elliptical flow distributor (EFD) from the same areas where plugged flow holes existed in the CSA. Figure 8-5 indicates the locations in the EFD where solidified material was observed in or above a flow hole.<sup>11,12</sup> As can be seen in the figure, these locations are in general agreement with the locations in Figure 8-4, where solidified material was observed in the CSA. As seen in Figures 8-4 and 8-5, many of the plugged flow holes line up quite well, which indicates that the flow moved vertically downward and covered much of the periphery of the CSA structure as it followed the flow hole alignment pattern onto the EFD. For example, the plugged holes near locations H-15, K-15, and L-15 shown in Figure 8-4 are near plugged locations H-15, K-15, and K-14 shown in Figure 8-5. Also, the plugged holes in location C-14 shown in Figure 8-4 are near the plugged holes in locations D-13 and D-14 shown in Figure 8-5.

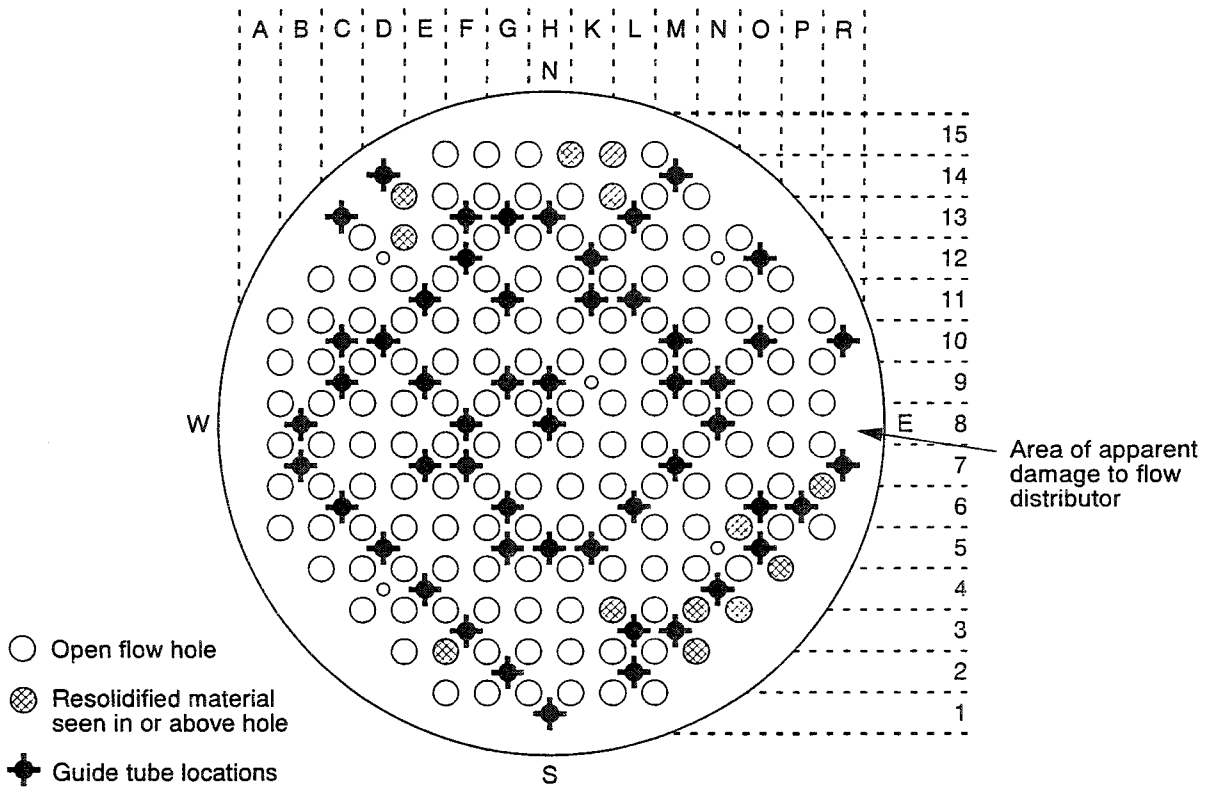
**Figure 8-5.** Solidified material in the elliptical flow distributor.

Some of the molten material solidified on the EFD and formed plugs in the flow holes at locations shown in Figure 8-5. The subsequent flow of material was probably diverted by the plugged holes and dropped onto the lower head from several different locations around the periphery of the EFD.

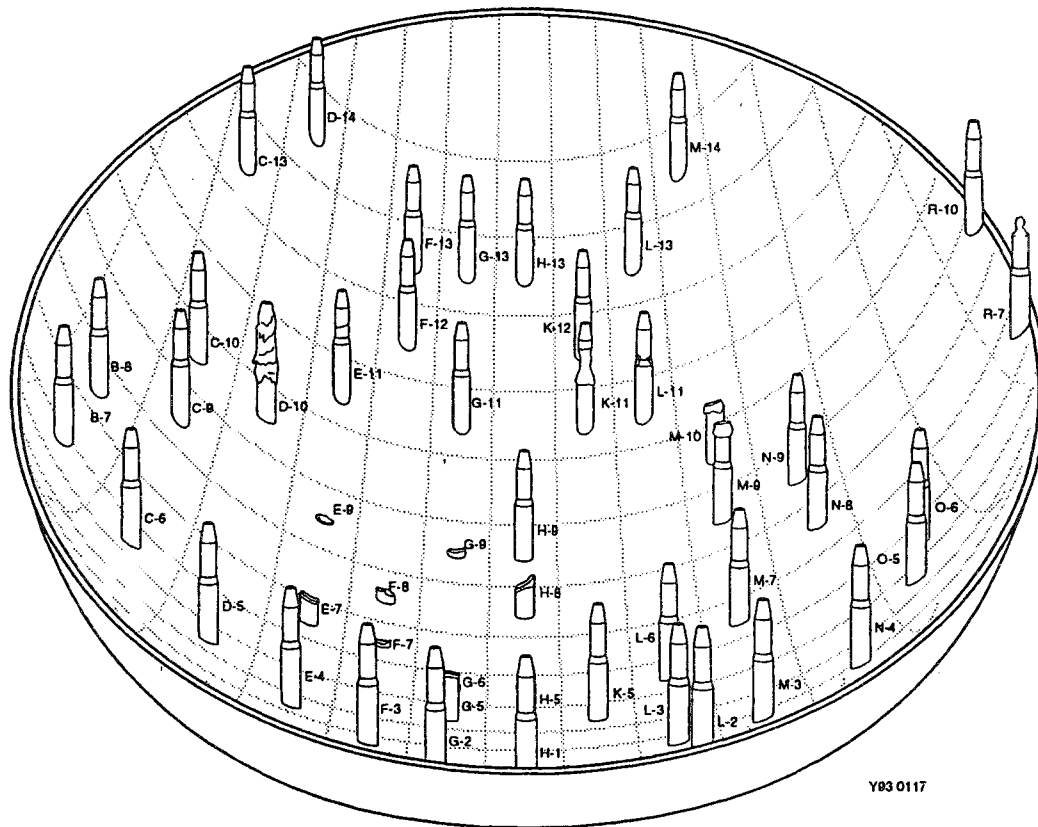
**Figure 8-6.** Nozzle damage profile.

The pattern of nozzle degradation observed at elevated levels for several nozzles is shown in Figure 8-6 and indicates the extent of the insulating ceramic debris layer that formed in the lower head and protected many of the nozzles and the lower head from extensive thermal damage. As the flow moved on top of the initial insulating debris layer, newly exposed molten fuel came in contact with the nozzles at elevated levels. These nozzles were melted at an elevation that is thought to be representative of the bottom of the molten fuel flow. Since the molten material flowed on top of the initial debris layer, this height is also representative of the thickness of insulating material that protected the lower head and the lower portions of many nozzles. As an example, examinations showed that the nozzle damage at M-9 was at about 25 cm above the lower head, and the damage to H-5 was about 15 cm above the head. Damage to nozzles around the M-9 and H-5 core locations, which have damage at elevations above the base of the nozzles, suggests that the insulating layer was approximately 25 cm thick at the M-9 location and 15 cm thick at H-5.

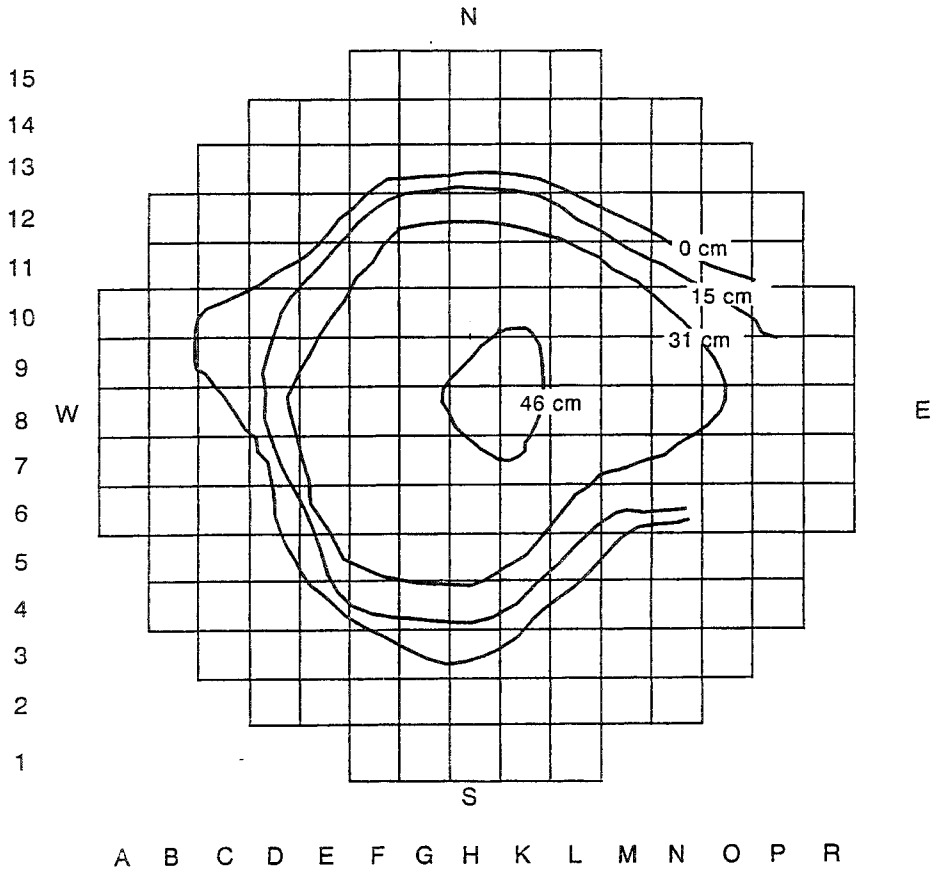
**Figure 8-7.** Hard layer debris depth. (Contour lines represent incremental increases, with the outside line equal to 0 cm and the inside equal to 46 cm.)

As the hotter molten material flowed across the top of the insulating ceramic debris layer, the cup-shaped structure that had initially formed on the lower head began to be filled. In the end, this resulted in what is known as the "hard debris layer," which is shown in Figure 8-7.<sup>15</sup> The debris depths shown in this figure were determined from mechanical probing of the hard layer during the defueling operation.

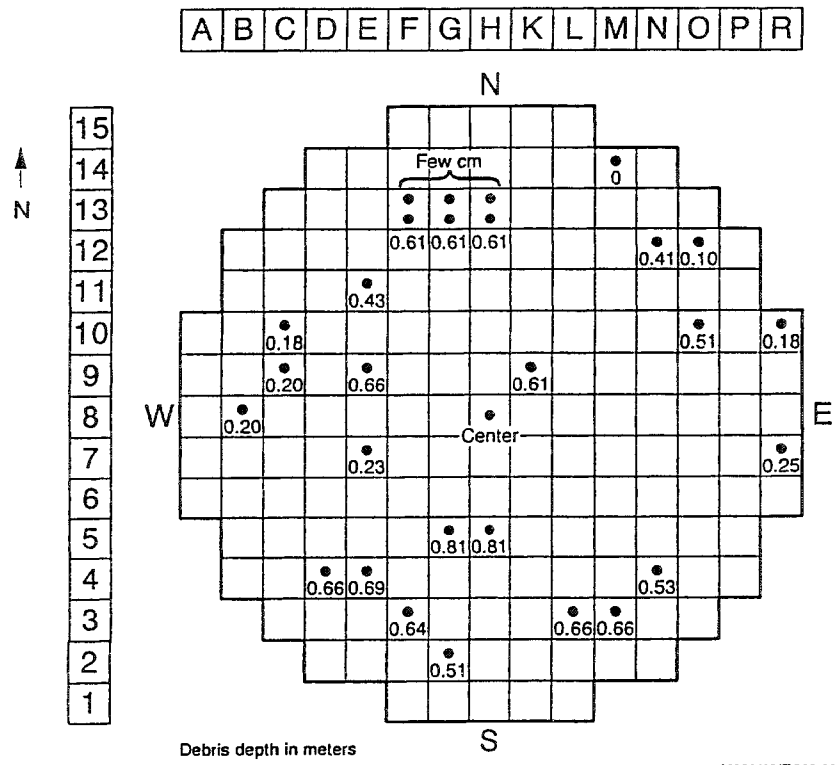
**Figure 8-8.** End state hard and loose layer debris configuration.

The last material to flow onto the lower head was what is known as the "loose debris layer." The depths of the loose debris layer are shown in Figure 8-8 and were determined before the defueling effort began.<sup>16,17</sup> The depths were determined by probing examinations and by analysis of video tapes taken of the lower head debris. Figures 8-9, 8-10, and 8-11 show cross sections of the hard debris layer thickness at several representative locations. As shown in these figures, there are relatively steep cliff-like areas along the periphery of the debris bed, and both full length and damaged nozzles are embedded in the debris.

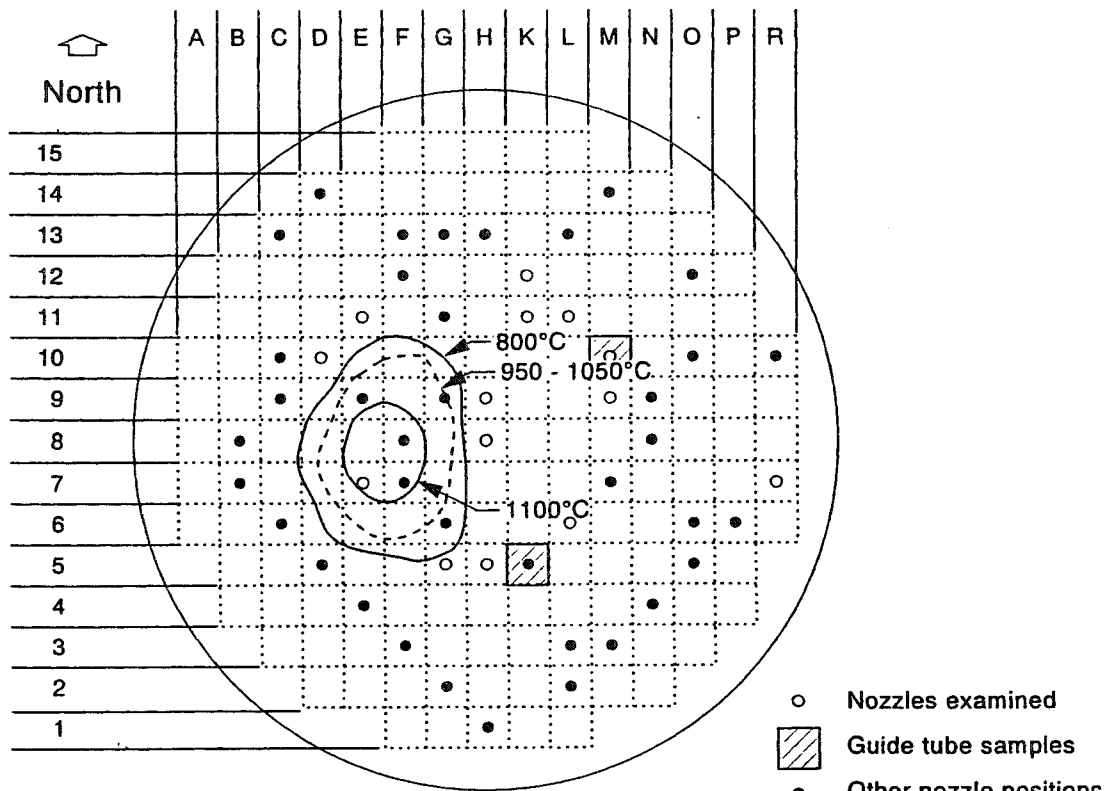
Figure 8-12. Lower head hot spot and nozzle/guide tube locations.

In addition to damaging the nozzles on the lower head, the flow of the hotter molten material may have also resulted in the formation of the localized lower head hot spot. It is postulated that as the hotter material flowed down the sides of the cup-like shape that was formed by the initial insulating crust towards the bottom of the vessel, the insulating layer crust became progressively thinner. Eventually, the flow of hotter material reached an area where the basal crust thickness was insufficient to adequately insulate the lower head, and a localized hot spot formed. The location of the hot spot on the lower head is shown in Figure 8-12.

- The pattern of molten material deposition on the lower head resulted in most of the vessel being insulated and protected from thermal damage. However, in the area just to the west of center (E-7, E-8, and F-8), the insulating layer was not sufficiently thick to protect the lower head, producing a localized hot spot.
