## 8. DEBRIS RELOCATION SCENARIO

J. R. Wolf and D. W. Akers, Idaho National Engineering Laboratory  
L. A. Neimark, Argonne National Laboratory

This section presents one possible scenario describing the relocation of debris to the lower head of the reactor vessel and is based on available plant instrumentation records and post-accident examination results. The scenario presented here is not the only potential debris relocation scenario, but is consistent with information obtained from plant data, VIP examinations, analysis efforts, and other TMI-2 programs.

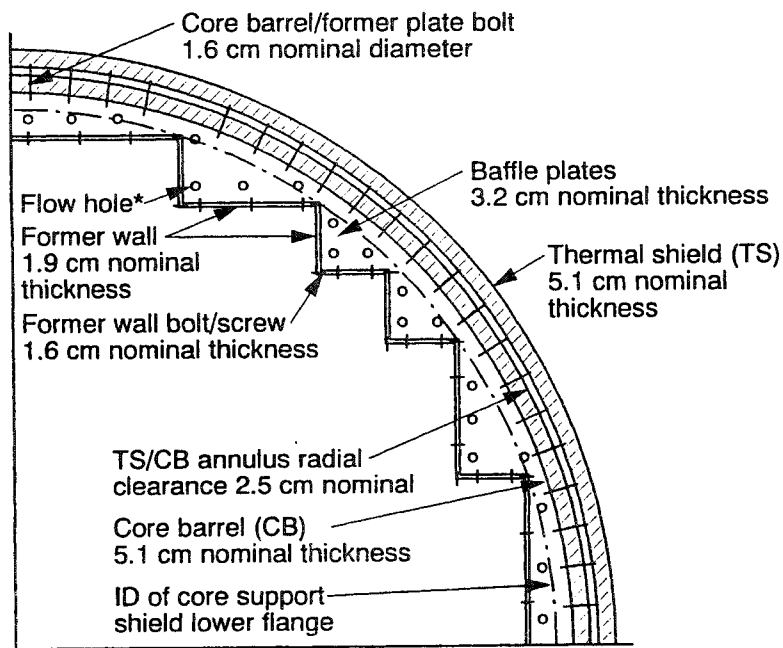
Figure 8-1. Reactor vessel internal structures.

At the bottom of the vertical core former plates, the molten material melted back into the lower core support assembly (CSA). Visual observations indicate a massive hole and damage in the bottom on the vertical core former wall located at core grid locations R-6, R-7, P-4, and P-5.

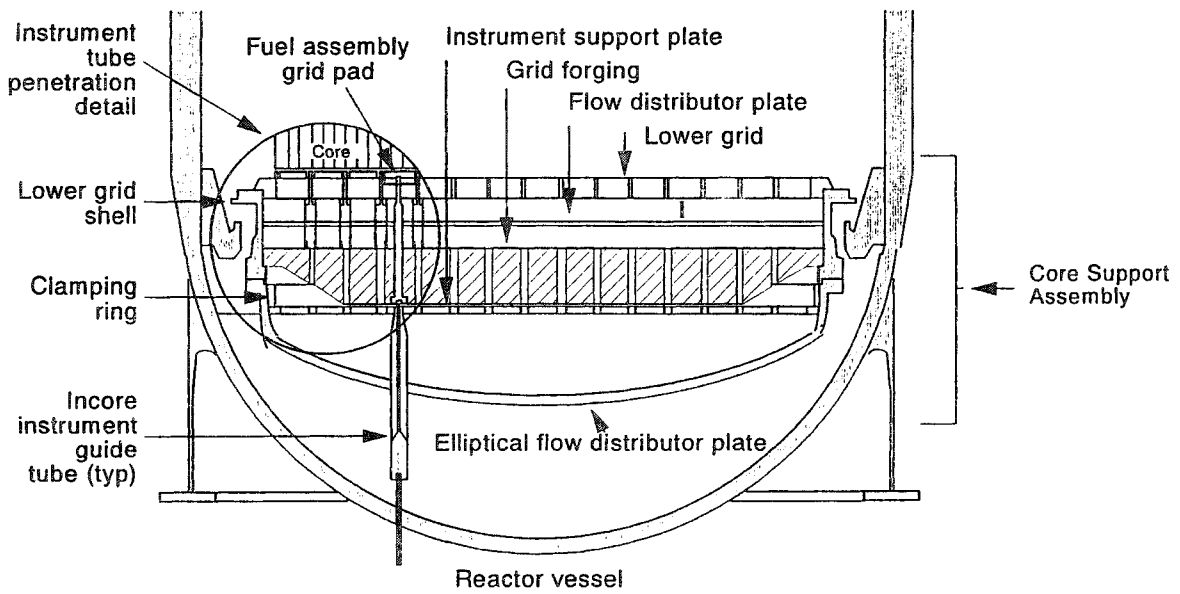
Figure 8-3. TMI-2 core support assembly.

The CSA geometry consists of a number of plates and forging and as shown in Figure 8-3. Once in the CSA, the majority of the molten material continued to flow down through the structures on the eastern periphery in the R-6/7 and P-4/5 area. However, visual examinations indicated that some of the molten material was found to have flowed around the perimeter of the CSA structures as it penetrated downward towards the lower head. Figure 8-4 shows the location of solidified material at several locations in the flow holes of the lower grid, the area between the lower grid and the flow distributor plate, and between the flow distributor plate and the grid forging. The presence of solidified material is assumed to indicate that molten material flowed through or adjacent to these locations.
